Boyd Property Group General Home Inspection Report

Exterior Inspection

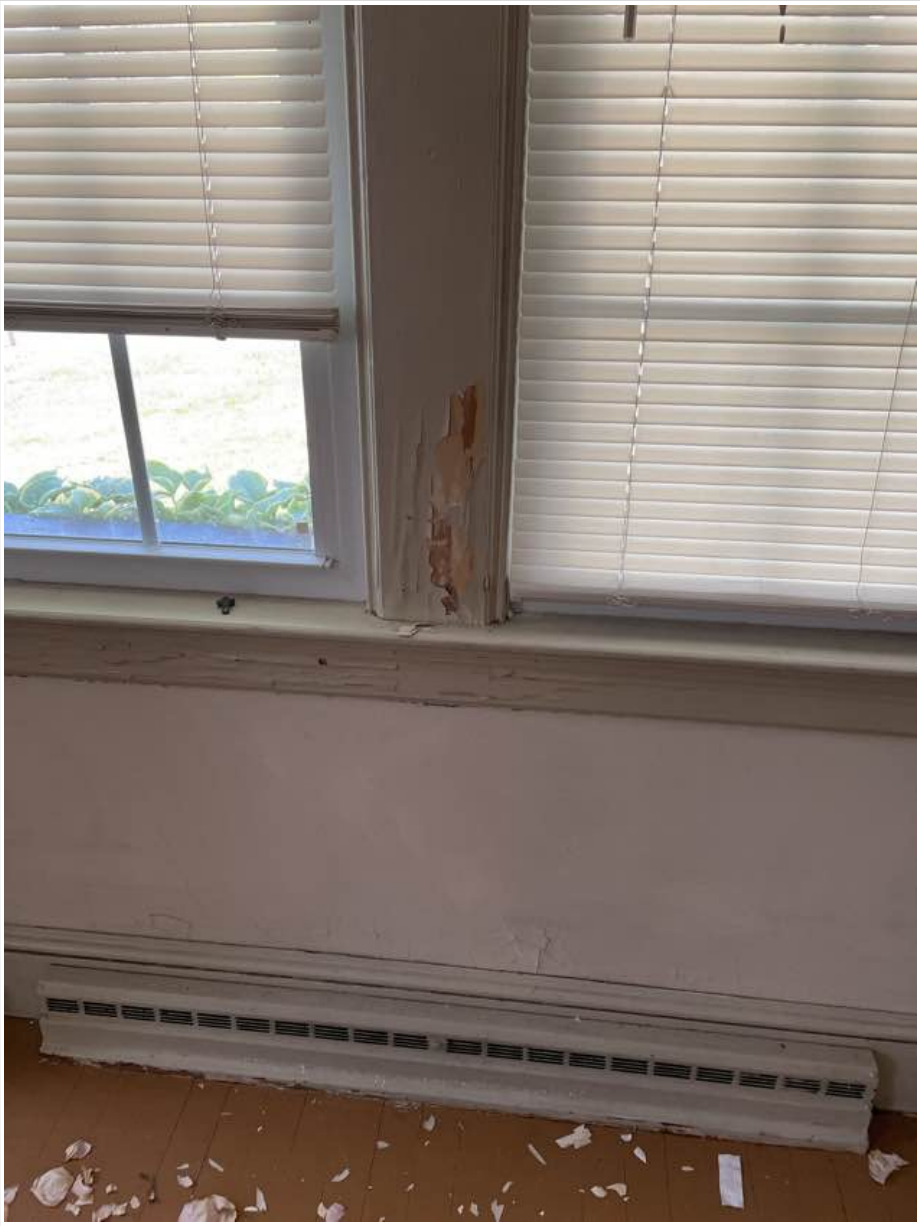
Entry door latches and locks	Yes
All entry door hardware, closers, glass, and other accessories are in operational condition	Yes
Windows are operational	Yes
Window coverings are present and undamaged	Yes
Notes	Peeling trim paint

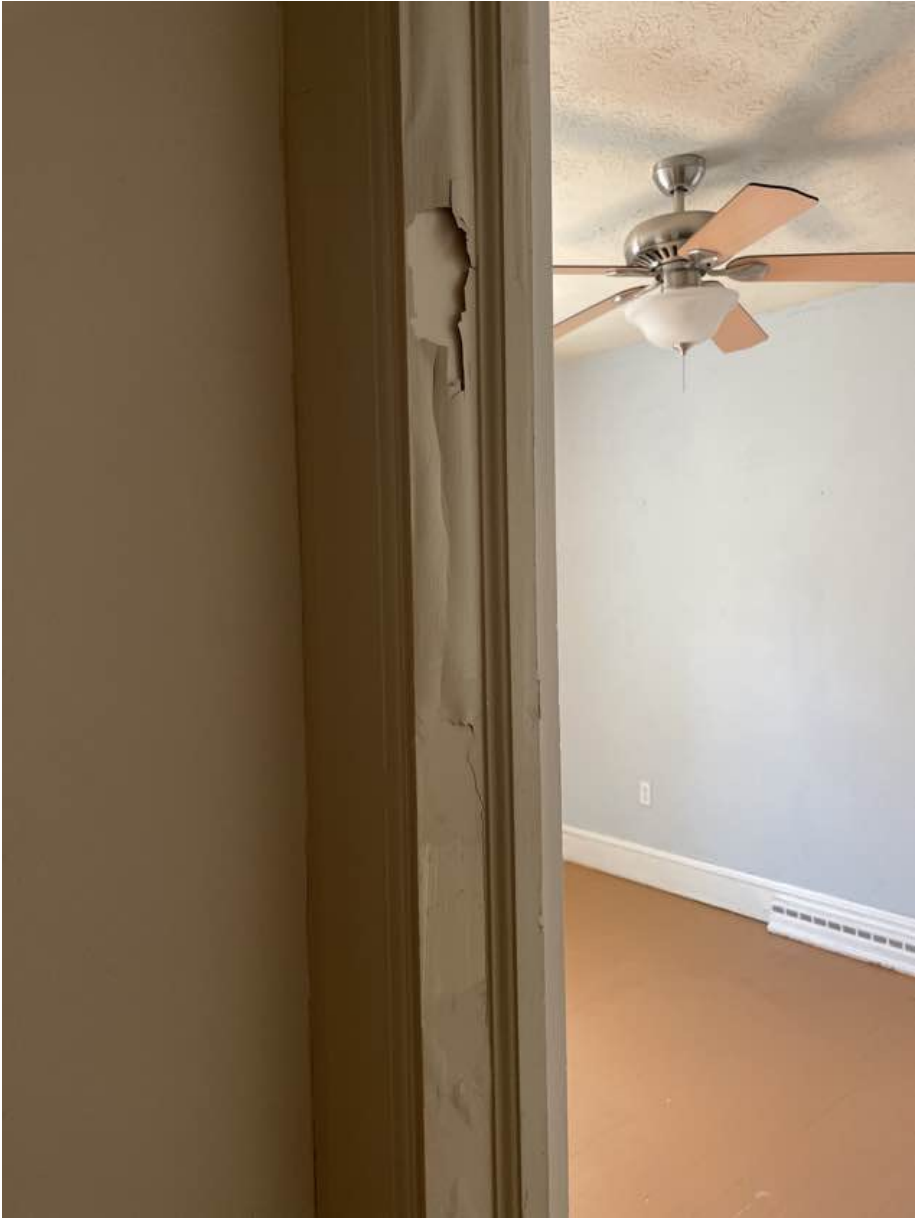
All light fixtures are present and operational	No
Wall surface is free of damage	Yes
Ceiling is free of damage	Yes
Floor is free from damage (Normal wear acceptable)	Yes
All painted surfaces are in good condition	No
All trim is in acceptable condition	No

All electrical outlets are in working condition	N/A
All light switches are in working condition	N/A
Windows are operational	N/A
Window coverings are present and undamaged	N/A
There is a working smoke detector present (test)	No
Note any deficiencies	
Photograph any damage or deficiencies

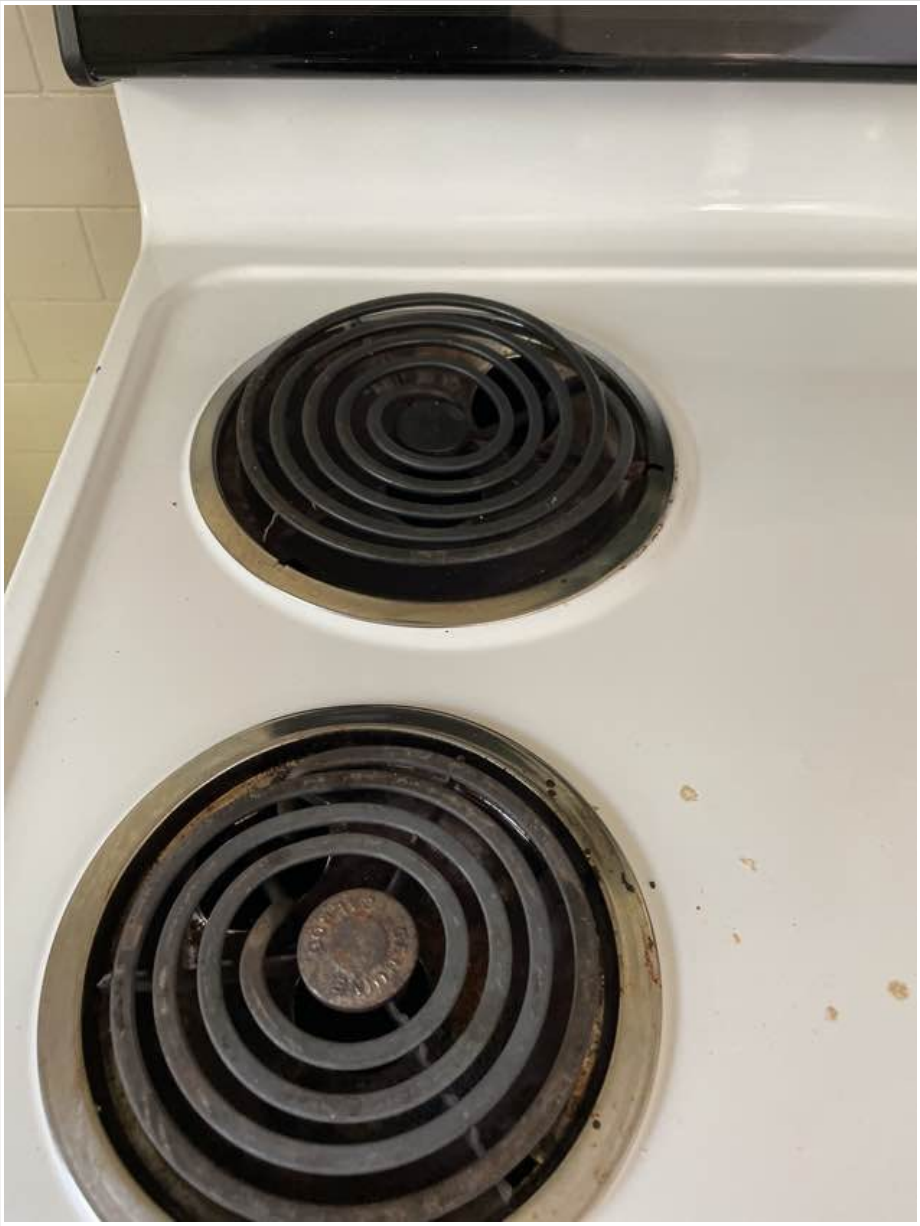
All light fixtures are present and operational	Yes
Wall surface is free of damage	Yes
Ceiling is free of damage	Yes
Floor is free from damage (Normal wear acceptable)	Yes
All painted surfaces are in good condition	Yes
All trim is in acceptable condition	Yes
All electrical outlets are in working condition	No
All light switches are in working condition	Yes
Windows are operational	Yes
Window coverings are present and undamaged	No
Landlord supplied appliances are in working condition	No
Plumbing fixtures are operational and free from leaks	Yes
Note any deficiencies	Left rear burner on stove does not work on stove

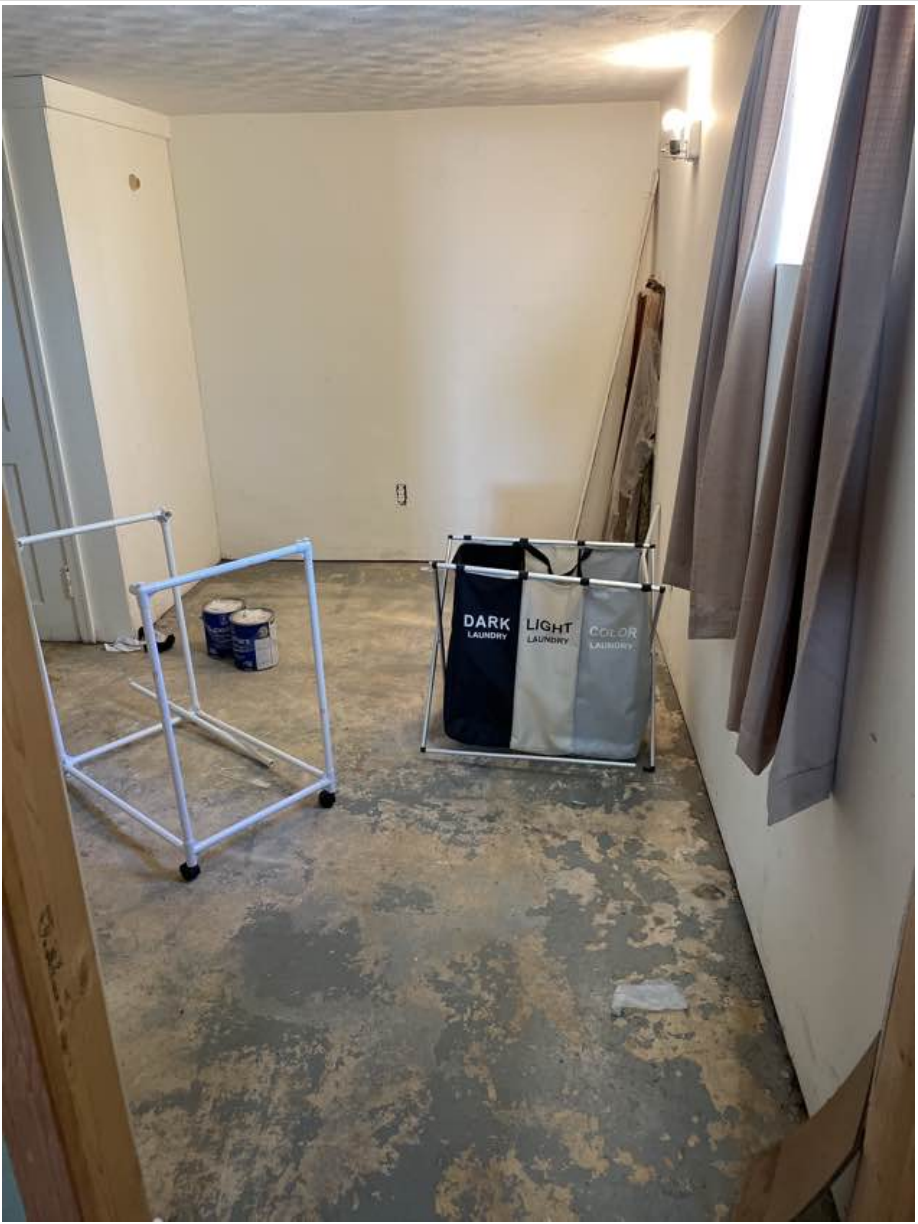
All electrical outlets are in working condition	Yes
All light switches are in working condition	Yes
Windows are operational	No
Window coverings are present and undamaged	Yes
A working smoke detector is present (test)	No
All light switches are in working condition	N/A
All plumbing and valves are in working order/free from leaks	Yes
The water heater has a pan installed beneath it	No
The washer has a pan installed underneath it (or a pan is present)	No
Note any deficiencies	Ceiling has old leak
