Boyd Property Group General Home Inspection Report

Exterior Inspection

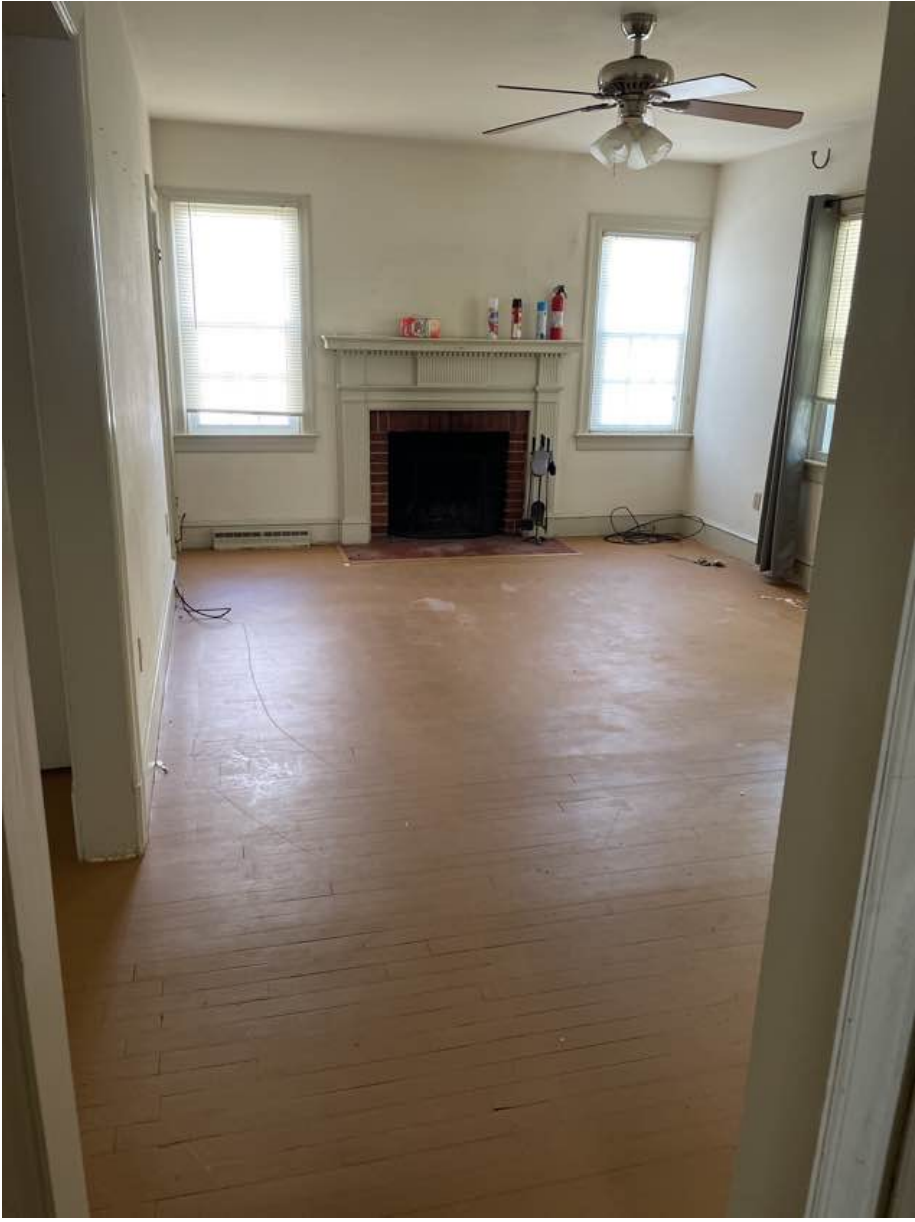
Living Room

All light fixtures are present and operational	Yes
Wall surface is free of damage	Yes
Ceiling is free of damage	Yes
Floor is free from damage (Normal wear acceptable)	Yes
All painted surfaces are in good condition	No
All trim is in acceptable condition	No

All electrical outlets are in working condition	Yes
All light switches are in working condition	Yes
Windows are operational	Yes
Window coverings are present and undamaged	Yes
There is a working smoke detector present (test)	No
Note any deficiencies	
Photograph any damage or deficiencies

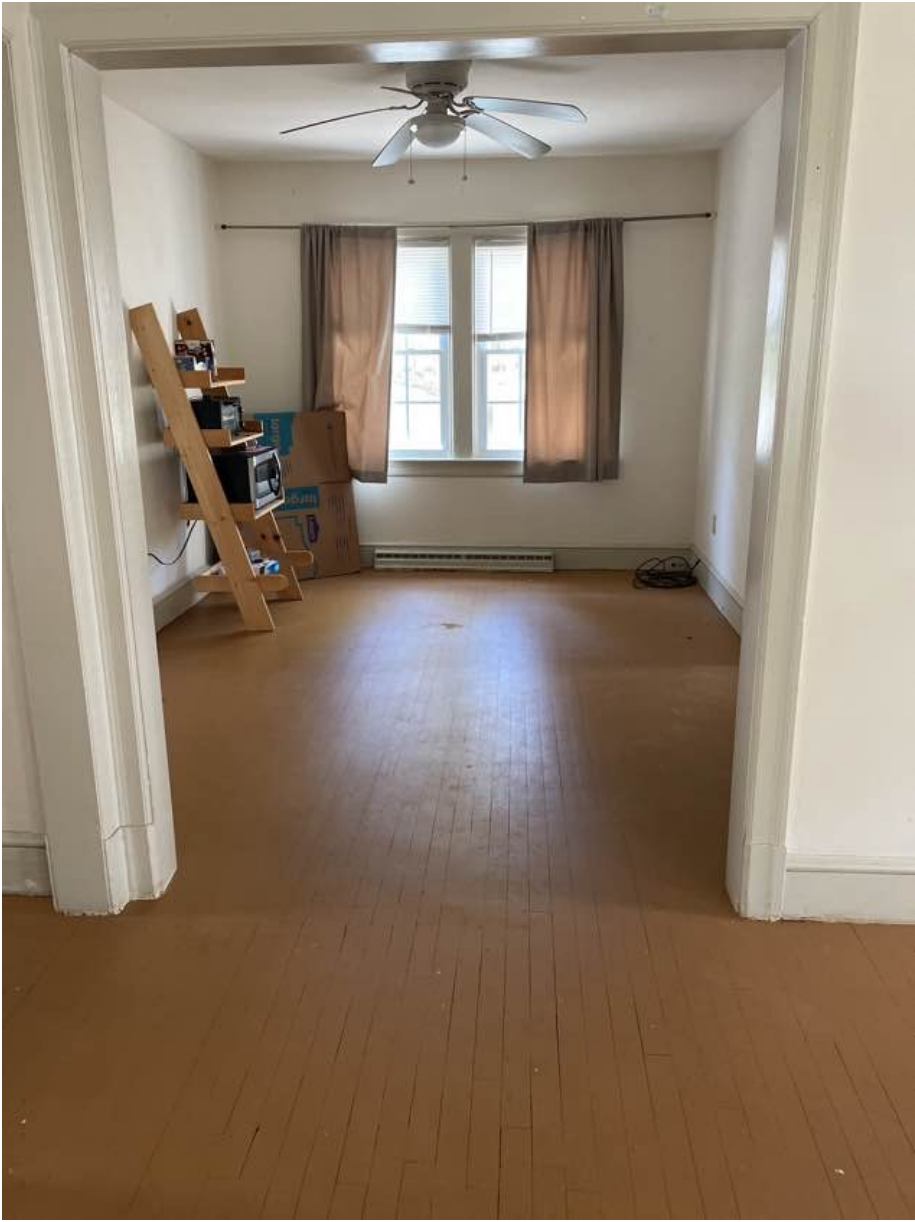
Bedroom 1

All light fixtures are present and operational	Yes
Wall surface is free of damage	No

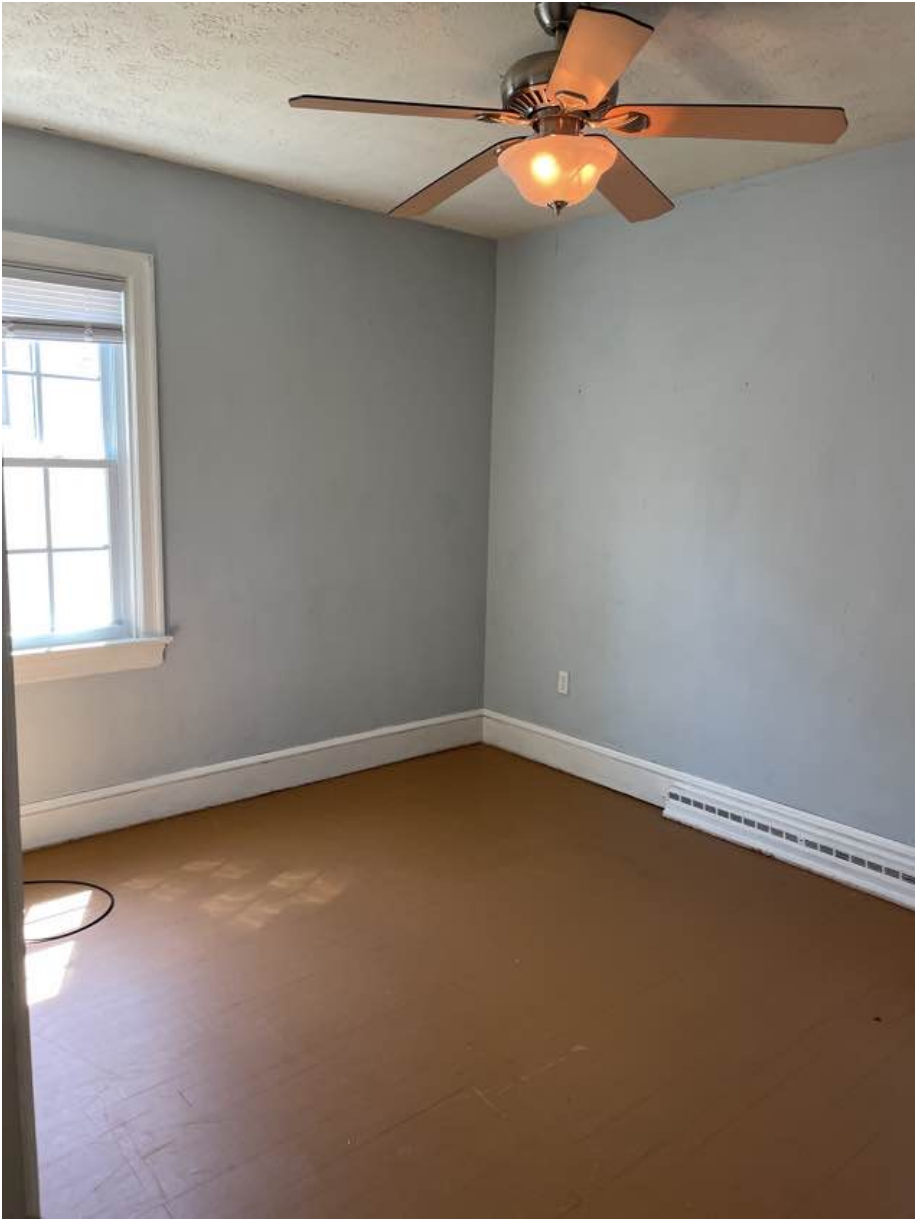
Bedroom 2

All light fixtures are present and operational	Yes
Wall surface is free of damage	No
Ceiling is free of damage	Yes
Floor is free from damage (Normal wear acceptable)	Yes
All painted surfaces are in good condition	No
All trim is in acceptable condition	Yes

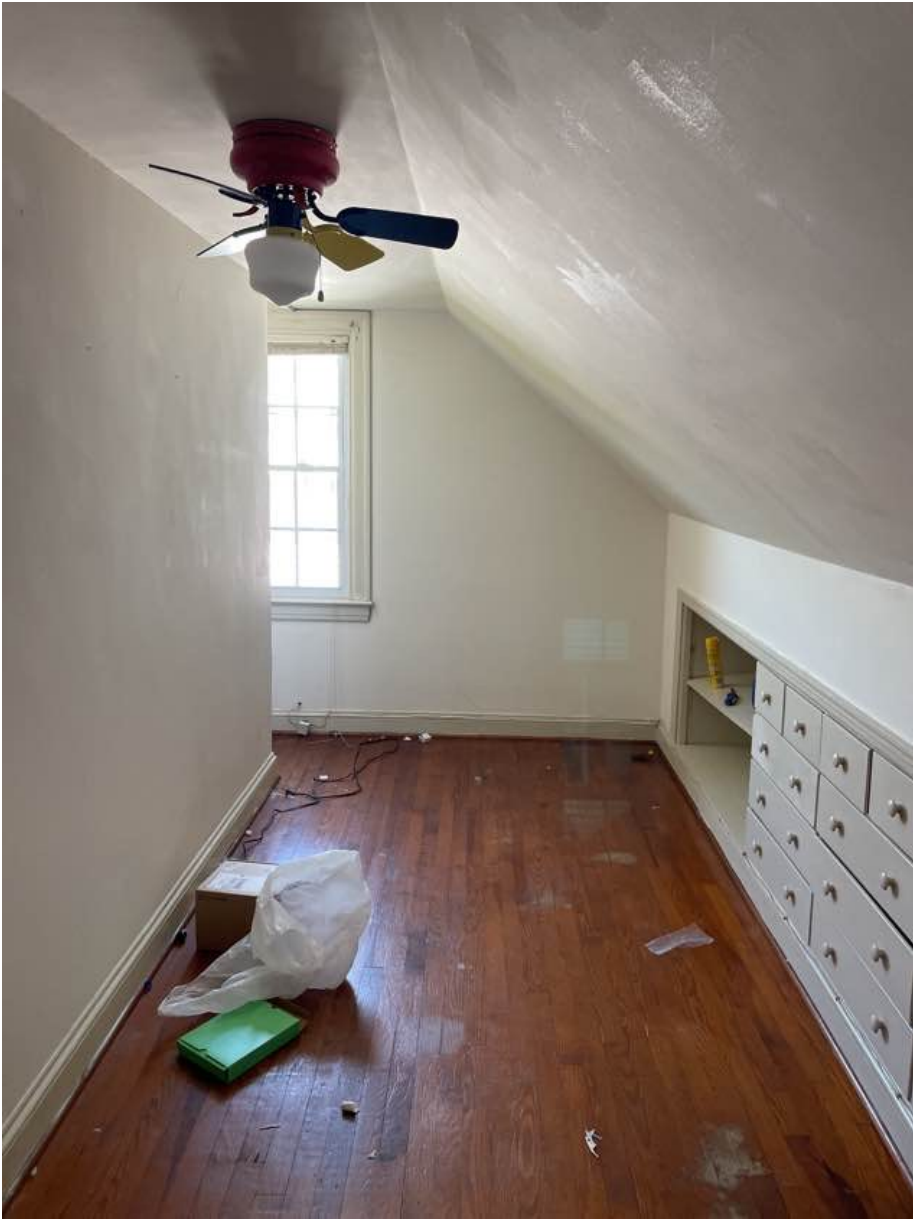
Bedroom 3

All light fixtures are present and operational	No
Wall surface is free of damage	No
Ceiling is free of damage	Yes
Floor is free from damage (Normal wear acceptable)	Yes
All painted surfaces are in good condition	Yes
All trim is in acceptable condition	Yes

All electrical outlets are in working condition	No
All light switches are in working condition	No
Windows are operational	Yes
Window coverings are present and undamaged	Yes
A working smoke detector is present (test)	No
All light switches are in working condition	N/A
Note any deficiencies	
Photograph any damage or deficiencies
